CAMP EDUSA, BARRACKS FOUNDATIONS
(Wettengel Elementary School)
Northwest of the intersection of Marine Corps Drive and Route 3
Dededo
Guam
Guam

HABS GU-5-A HABS GU-5-A

HISTORIC AMERICAN BUILDINGS SURVEY

HABS No. GU-5-A

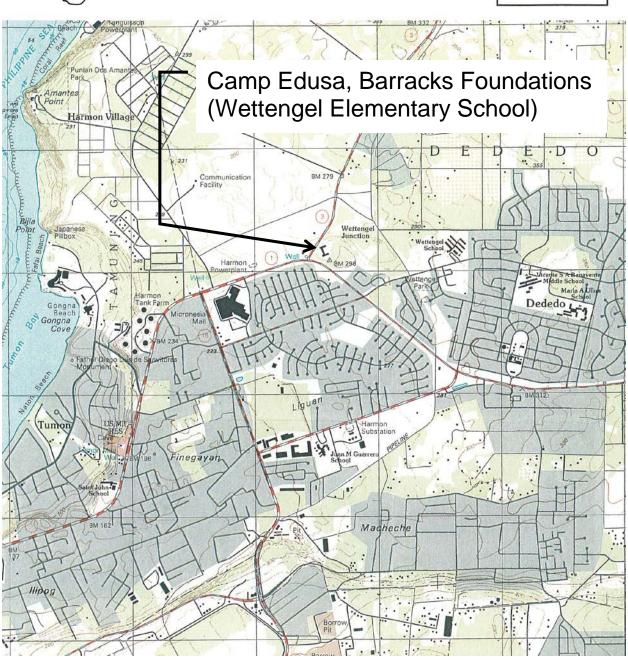
Field sketch of the three concrete slabs forming the H-shaped foundation, and the associated features. (Prepared by Mason Architects, Inc.)

The extant architectural features at the Camp Edusa property are a series of three large rectangular concrete slab foundations arranged in an overall H-shaped footprint with total measurements of about 263'-8" x 168'-8". Each of the individual slabs making up the H have measurements of 168'-8" x 36'-8". The terrain is wooded, and gently slopes down from higher ground at the east.

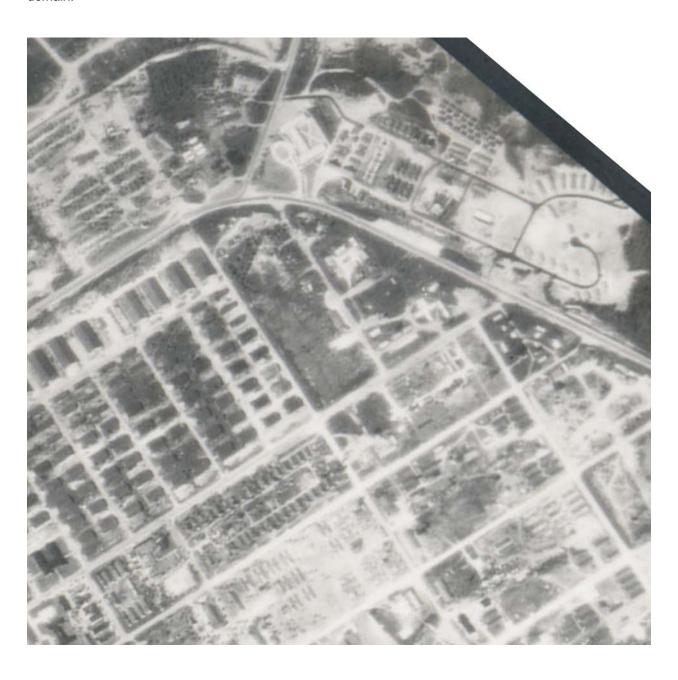
Portion of an aerial photo dated March 18, 1949 showing Camp Edusa. North at top. *Photo from the MAGIS Collection at the University of Hawaii at Manoa, USGS HI-PAC, Guam, 1949, VU-9, Sortie 31, Flt. 11, photo # 6. March 18, 1949. This photo was taken by a U.S. Navy aircraft flying photo reconnaissance over Guam and is in the public domain.*

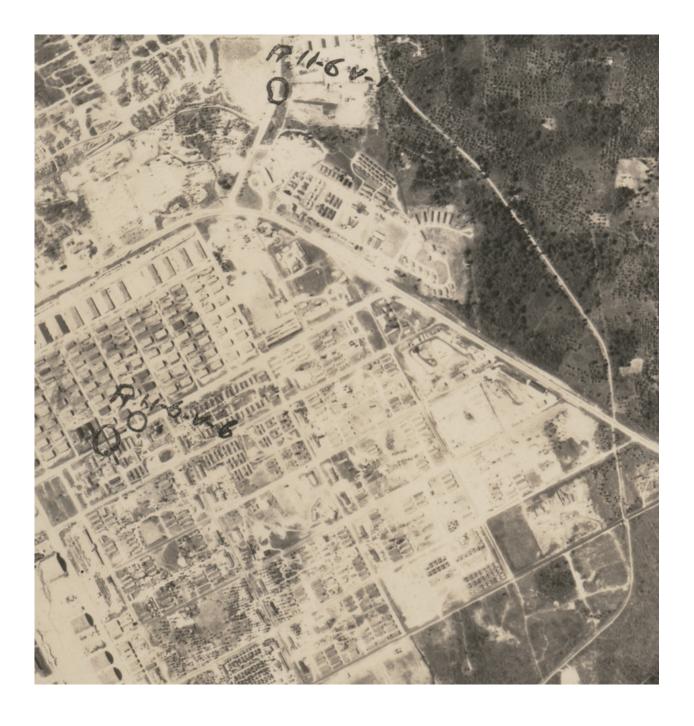
Portion of an aerial photo dated January 26-28, 1953 showing Wettengel Elementary School at former Camp Edusa. North at top. *Photo from the MAGIS Collection at the University of Hawaii at Manoa, USGS HI-PAC, Guam, 1953, VU-5-193, Flight 6, photo # 20-6. January 26-28, 1953. This photo was taken by a U.S. Navy aircraft flying photo reconnaissance over Guam and is in the public domain.*

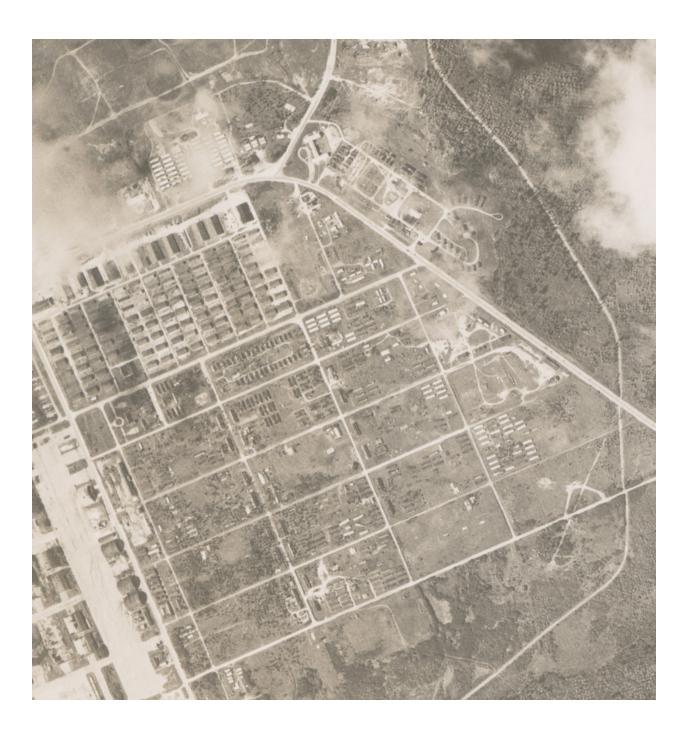
Portion of an aerial photo dated December 15, 1966 showing Wettengel Elementary School at former Camp Edusa. North at top. Note that by this date most all of the other structures of former Camp Edusa have been removed. *Photo from the MAGIS Collection at the University of Hawaii at Manoa, USGS HI-PAC, Guam, 1966, V1 VAP-61 USN 4489, photo # 122. December 15, 1966. This photo was taken by a U.S. Navy aircraft flying photo reconnaissance over Guam and is in the public domain.*
